Building and Pest Inspection Reports

In accordance with AS 4349.1 and AS 4349.3

1453 Sample street, Sampleville

24th April 2013 at 8:30am

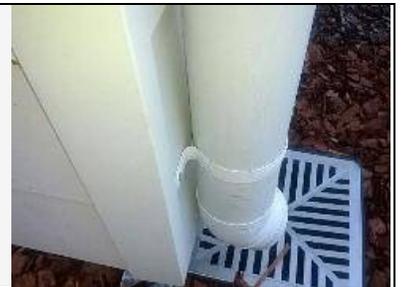
Recent painting and re-painting has not been performed in a tradesmanlike manner. This is a Minor Defect. This affects the appearance of the Building. I recommend you consult a licensed Painter about the necessity and cost of repainting.

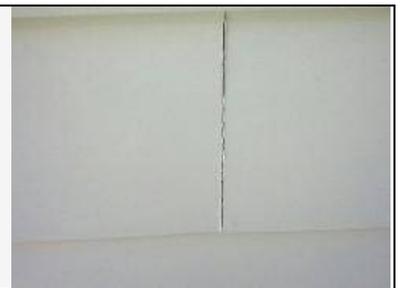
Some joins in the weatherboards have shrunk and pulled apart. This can allow water entry that will cause damage. This is a Minor Defect. Repair or replacement is required. Consult a licensed tradesperson about the scope of works and cost to rectify.

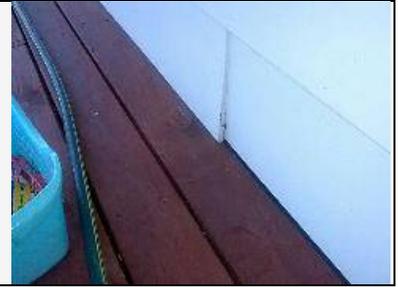
Weatherboard joint out of alignment to the Southern elevation. Refer to sample photo. This is a Minor Defect. Repair or replacement is required. Consult a licensed tradesperson about the scope of works and cost to rectify.

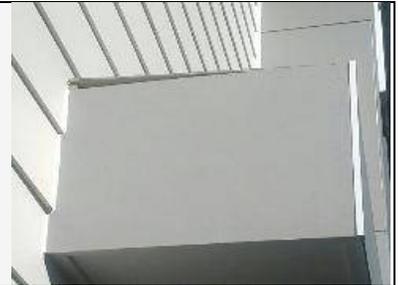
Trim and sealant missing to bulkhead above garage panel door. Refer to sample photo. This is a Minor Defect. Repair or replacement is required. Consult a licensed tradesperson about the scope of works and cost to rectify.

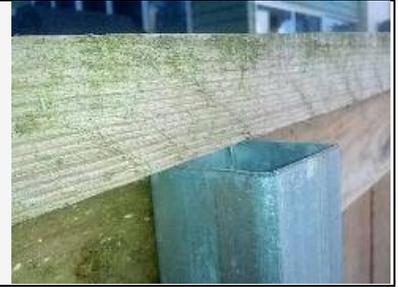
No caps onto fence posts. This will allow water to collect inside the post and cause rust. Caps to be installed. This is a Minor Defect. Repair or replacement is required. Consult a licensed tradesperson about the scope of works and cost to rectify.

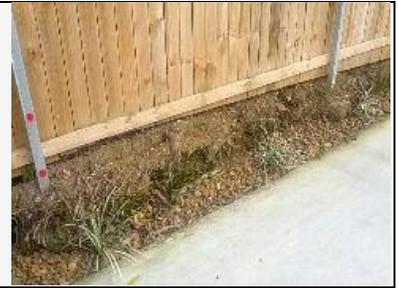
No retaining wall to the North boundary under the timber fence. This is a Minor Defect. Repair or replacement is required. Consult a licensed tradesperson about the scope of works and cost to rectify.

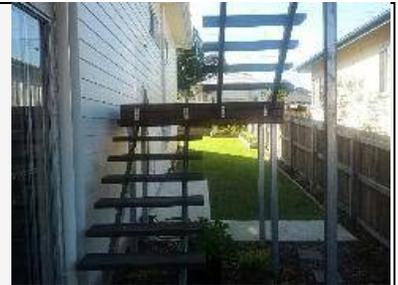
There are no handrails to the sides of the stairs. This is unsafe and may cause a person to fall and injure themselves. Handrails should be installed to both sides of the stairs to reduce the risk of an accident. I recommend that you contact a licensed tradesperson and have this problem rectified without delay.

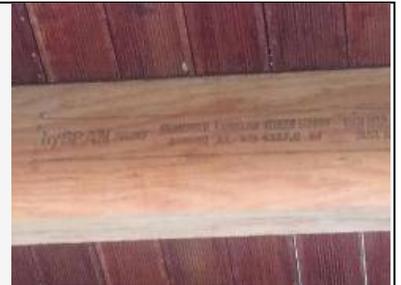
Hyspan project laminated beams are not painted. These are exposed to weather. I recommend you ensure these have adequate durability. Ask the Building Certifier to confirm that beams have adequate durability for this installation.

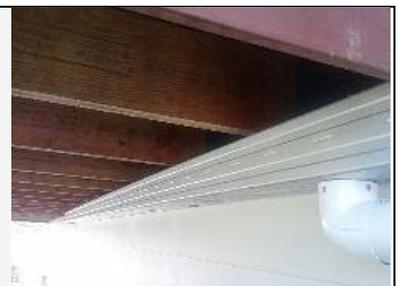
There is a gutter and some flashings installed to aid in catching water that may blow onto the deck floor in a storm or from mopping etc. Any failure of this system will result in water entry to the building that will cause damage. In my opinion this type of design and construction is undesirable as they are more than likely to leak at some point in the future. This opinion is based on my experience as a Building Inspector. I recommend that you confirm that this work is covered by the BSA Home Warranty Scheme, otherwise if it leaks you will be up for the cost of the rectification.

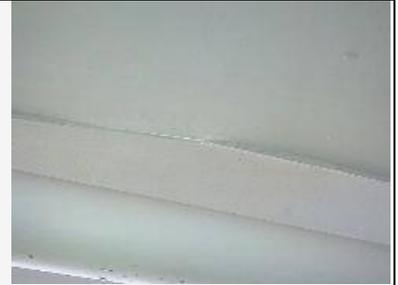
The curved plasterboard ceiling has not been finished to a high standard. The large amount of natural light accentuates the many imperfections in the ceiling finish. A Plasterer may need to replace the ceiling to obtain an acceptable level of finish. This is a Minor Defect as it is cosmetic only (from what can be seen). NB This area was tested with an Electronic Moisture Meter. The moisture level recorded was within a normal range.

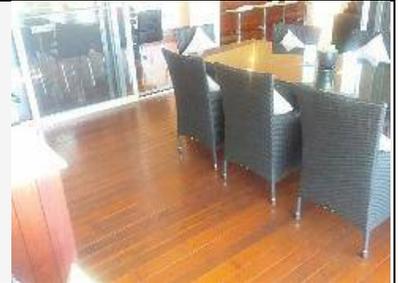
There appears to be insufficient fall and step down from the deck to the internal floor level. This may contribute to future water entry problems. I recommend that you ask the Building Certifier to confirm that the deck and its drainage/waterproofing method complies with the Building Code of Australia.

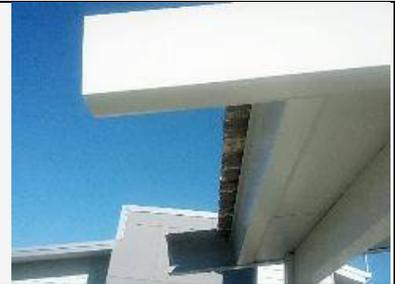
Cap flashings to gate house roof are incomplete. This is a Minor Defect. Repair or replacement is required. Consult a licensed tradesperson about the scope of works and cost to rectify.

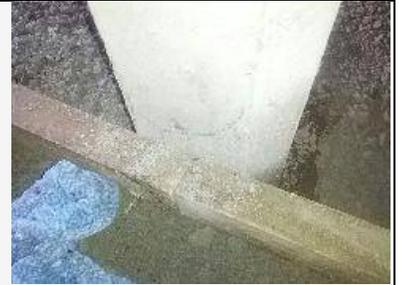
One concrete stump is cracked. This cracking is due to the corrosion of steel reinforcement inside the stump. This corrosion causes the steel to expand. The expansion exerts enough force to crack the concrete stumps. Ask a restumper to further investigate this problem and advise if the stump is so badly cracked that they may have to be replaced. In addition to replacing any badly cracked stumps, the surface drainage should be improved to reduce the volume of water that flows under the house. To improve the surface drainage you will need to install a suitable stormwater drainage system. This drainage system should be designed and installed by a licensed plumber or drainer.

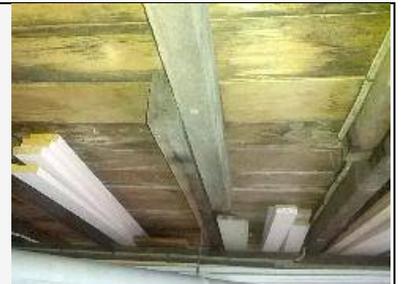
The subfloor framing appears to be adequate. Two floor joists under the bathroom on the South side if the sub floor are not properly connected. Builder to rectify.

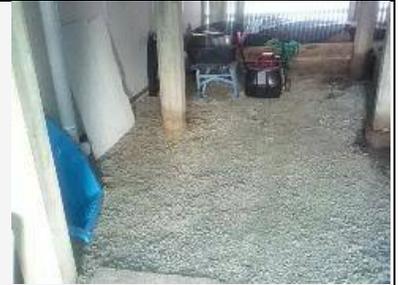
The drainage under the house appears to be inadequate. Water may cause damage to the building or be a nuisance. It is recommended that you consult a licensed plumber or drainer regarding the installation of a suitable system of surface drainage, this system may consist of a retaining wall and open concrete spoon drains connected to large grated pits (for inspection and cleaning) connected to stormwater drainage system would be suitable.

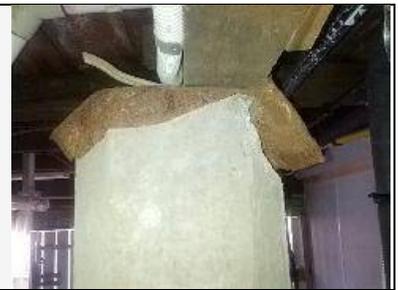
There is severe rust to sections of ant capping. This is a damage defect. This may compromise the intended purpose of the component. Recommend having a Builder provide a scope of works to replace rusted ant capping with code compliant antcapping.

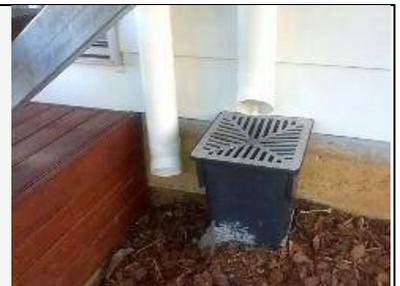
Some downpipes do not appear to be connected to an approved point of discharge such as council stormwater drains, rubble pits, or street kerb and channel. Refer to sample photo of Southern elevation. This should be rectified by a licensed plumber.

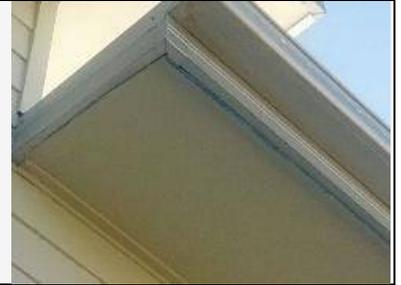
Masking tape not removed from eaves to the Southern elevation. Refer to sample photo. This is a Minor Defect. Remove tape.

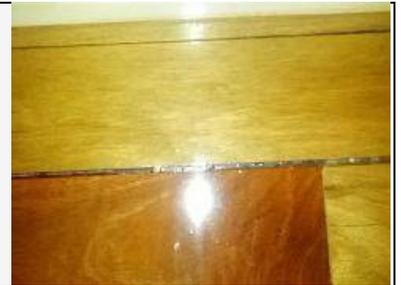
Excessive gap to floating floorboards. Approx. 4mm width to south end of living room. This is a Minor Defect. Repair or replacement is required. Consult a licensed tradesperson about the scope of works and cost to rectify.

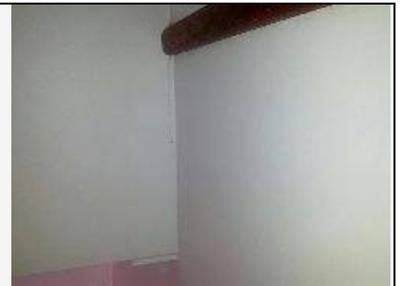
Minor settlement crack above the internal stairs to the ground floor. This is a Minor Defect. Repair or replacement is required. Consult a licensed tradesperson about the scope of works and cost to rectify.

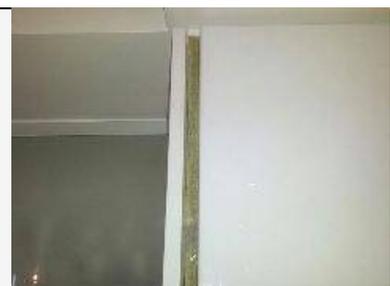
Trims missing either side of cupboard above the fridge alcove. This is a Minor Defect. This component has not been correctly installed. Repair or replacement is required. Consult a licensed tradesperson about the scope of works and cost to rectify.

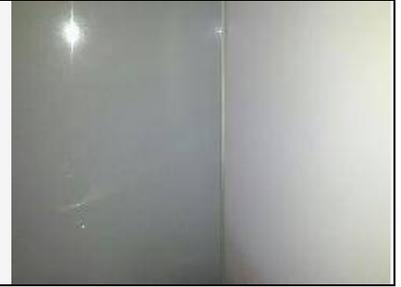
Silicone is missing to ends of splashbacks and other joints. This component has not been correctly installed. This is a Minor Defect. Repair or replacement is required. Consult a licensed tradesperson about the scope of works and cost to rectify.

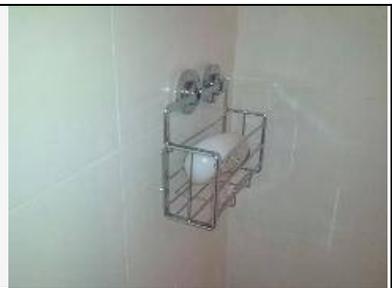
The condition of the bathroom accessories is generally good. Suction cup soap basket in shower. This is temporary only. A new soap basket should be installed. This is a Minor Defect.

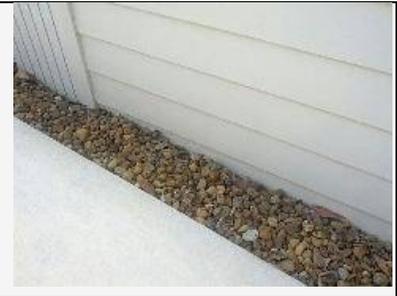
Inspection of the concrete floor slab edge was restricted. In our experience, termites most commonly enter over the slab edge and therefore we recommend modifications be made to expose the slab edge, see Section 4.0 - Concrete Slab Homes (part or full). The following items restricted access to the edge of the slab - soil, gravel.
