Building and Pest Inspection Reports

In accordance with AS 4349.1 and AS 4349.3

1453 Sample street, Sampleville

24th April 2013 at 8:30am

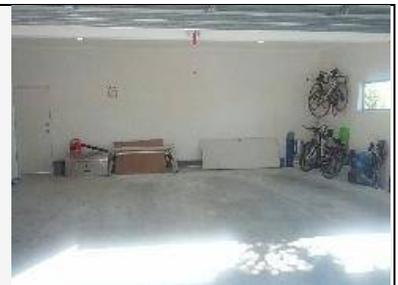
The general condition of the walls, windows, ceiling, floor, doors, and woodwork is good.

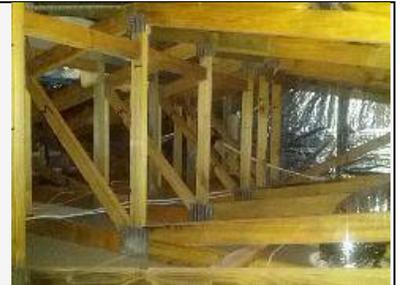
The truss roof system appears to provide adequate support.

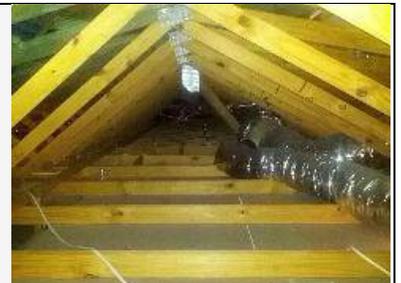
The roof is insulated with "Blanket" type insulation.

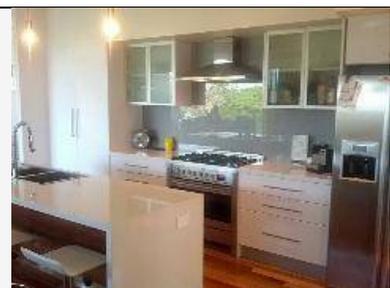
Top floor.

Minor plasterboard, paint and sealant defects in various sections of the house. This is a Minor Defect. Repair or replacement is required. Consult a licensed tradesperson about the scope of works and cost to rectify.

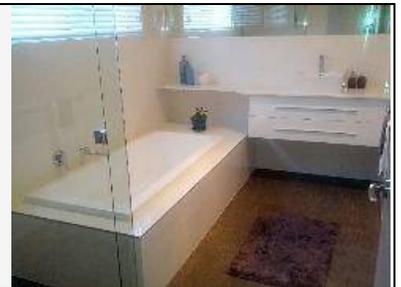
On the left hand side of the building.

The shower appears to be generally in a good condition. The shower recess was inspected and where access permitted a moisture meter was used, and there was no visible water penetration to surrounding areas. IMPORTANT NOTE: This test may not reveal water leaks until the shower is put into constant use and surrounding areas monitored over a period of time.

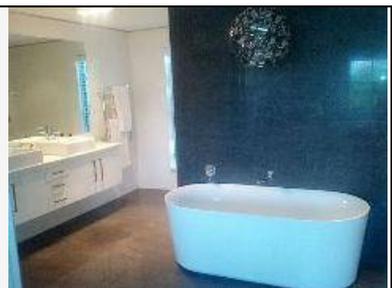
Top floor.

The shower appears to be generally in a good condition. The shower recess was inspected and where access permitted a moisture meter was used, and there was no visible water penetration to surrounding areas. IMPORTANT NOTE: This test may not reveal water leaks until the shower is put into constant use and surrounding areas monitored over a period of time.

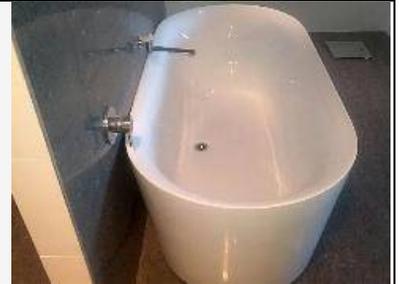
The bath is generally in a good condition.

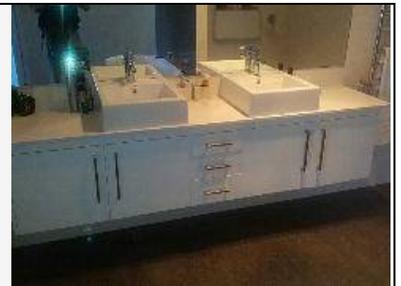
The condition of the wall tiles is generally good.

The basins and taps are generally in a good condition.

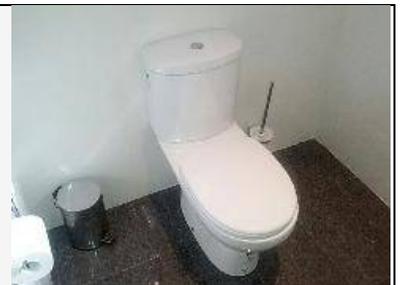
The condition of the vanity unit is generally good.

The toilet appears to be in good condition.

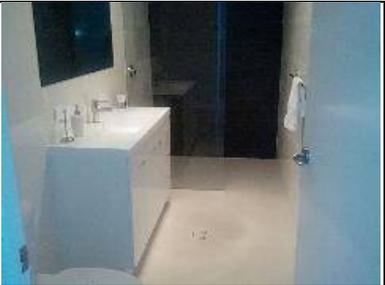
Ground floor.

The shower appears to be generally in a good condition. The shower recess was inspected and where access permitted a moisture meter was used, and there was no visible water penetration to surrounding areas. IMPORTANT NOTE: This test may not reveal water leaks until the shower is put into constant use and surrounding areas monitored over a period of time.

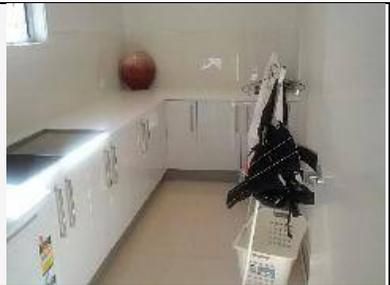
Ground floor.

The laundry tub and taps are generally in a good condition.

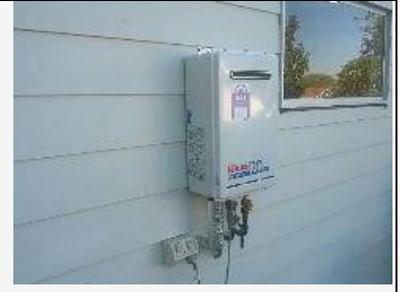
The hot water system appears to be in working condition. No specific tests other than running the hot water from a tap was carried out. No determination has been made as to the compliance, suitability or adequacy of the hot water system in relation to capacity or otherwise. Located externally:
Gas hotwater system:

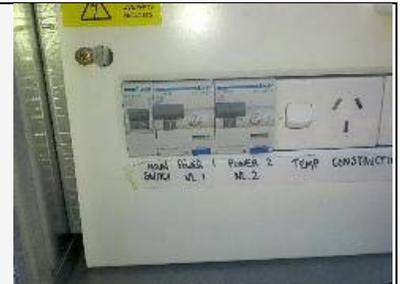
- There is a Earth Leakage Circuit Breaker (Safety Switch) installed however, the operation or adequacy was not tested and is not commented on.
